# Portage Creek Sediment Remediation Project Kalamazoo, Michigan

Post-Sediment Removal Structure Feature Assessment  
Removal Areas SA5-Axtell, SA5-D and SA5-C

F&V Project Number: 809930  
October, 2012

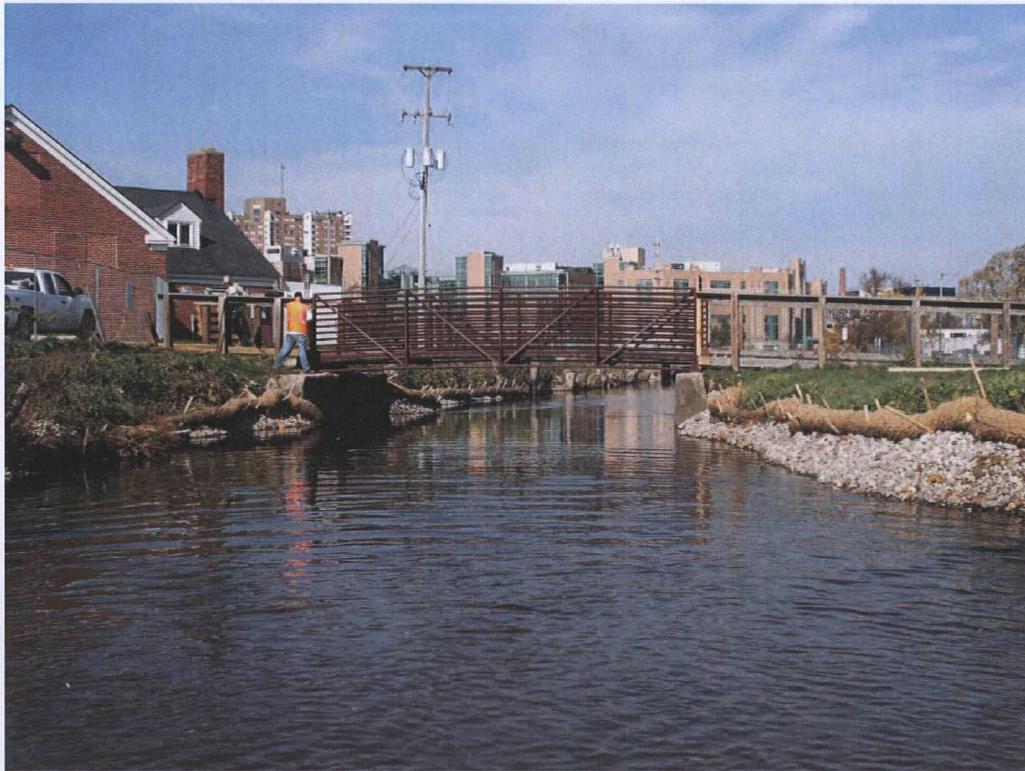
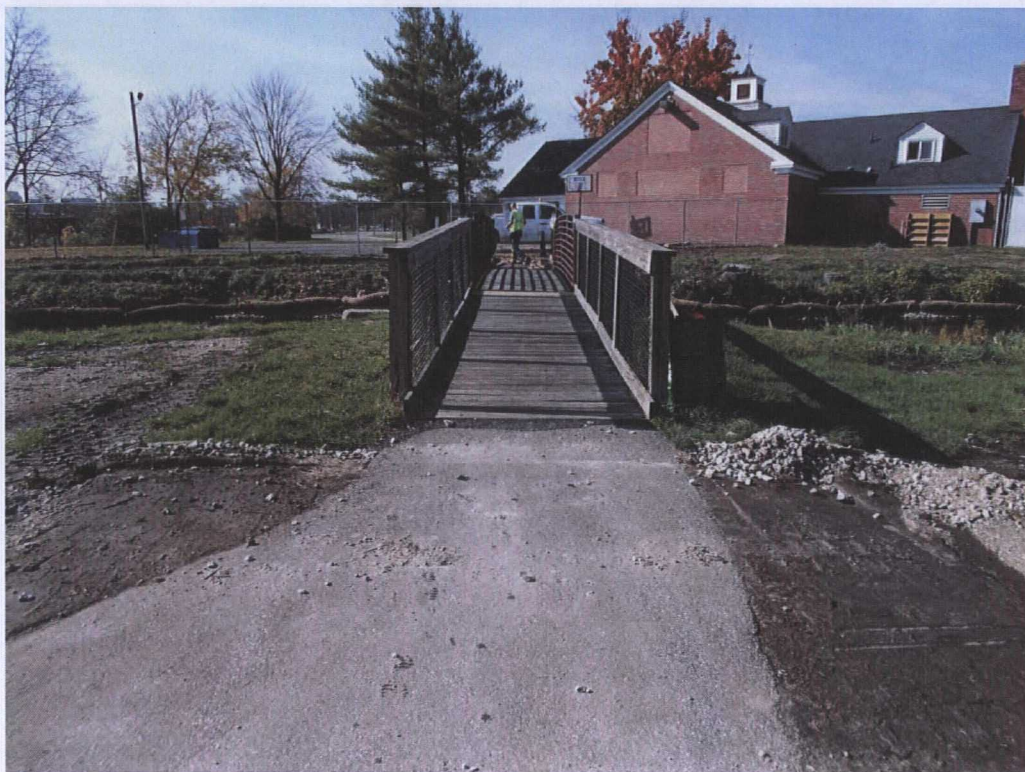
- The superstructure was removed and replaced to accommodate sediment removal.
- EQM was in the process of restoring approach railings at the time of evaluation.
- The structure does not appear to have been impacted during sediment removal.

Elevation view of the structure from the upstream channel

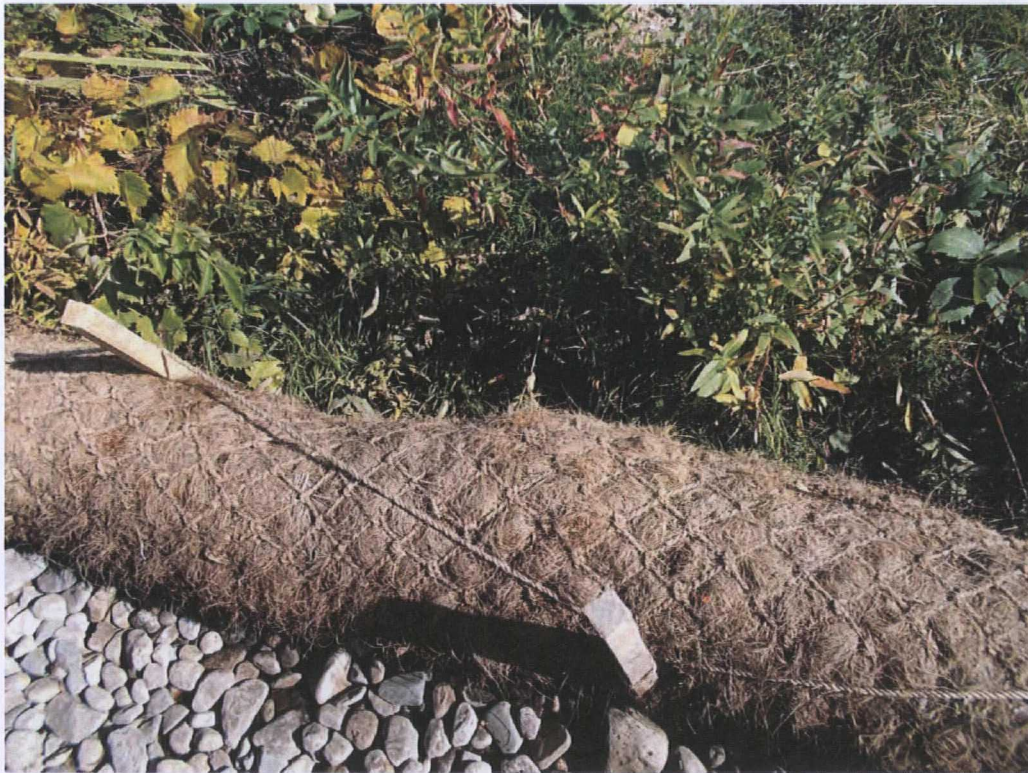
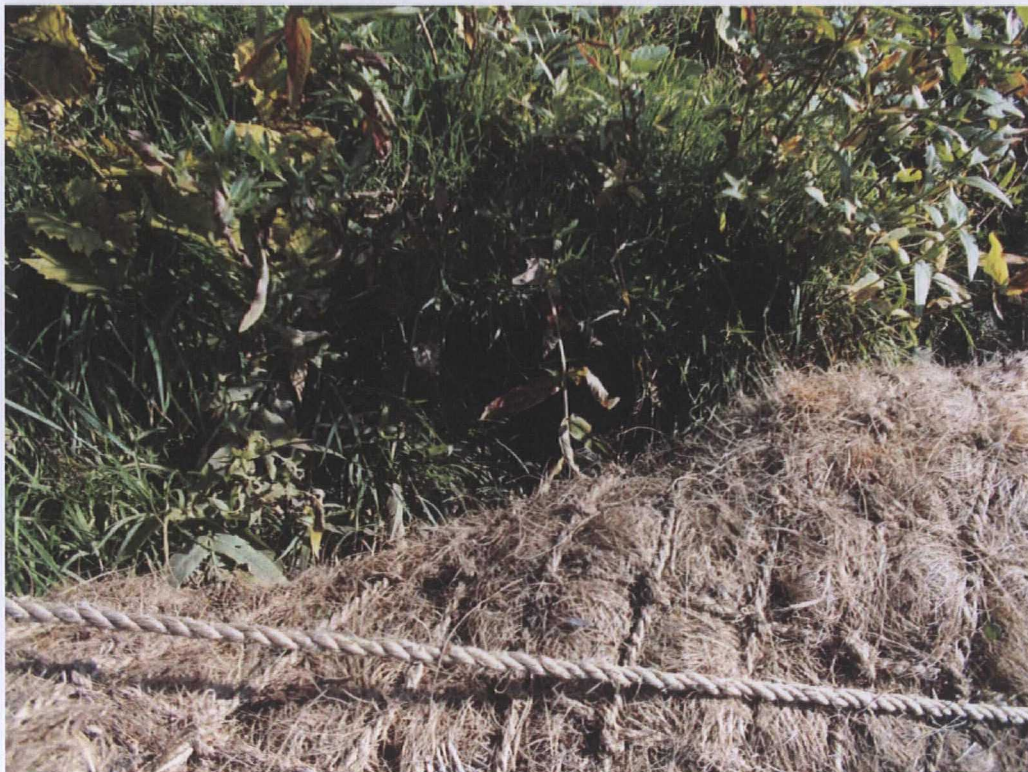
- The structure does not appear to have been impacted during sediment removal.
- The core log restoration was installed in front of the outlet and should be adjusted to prevent blockage.

View of the outlet from the channel

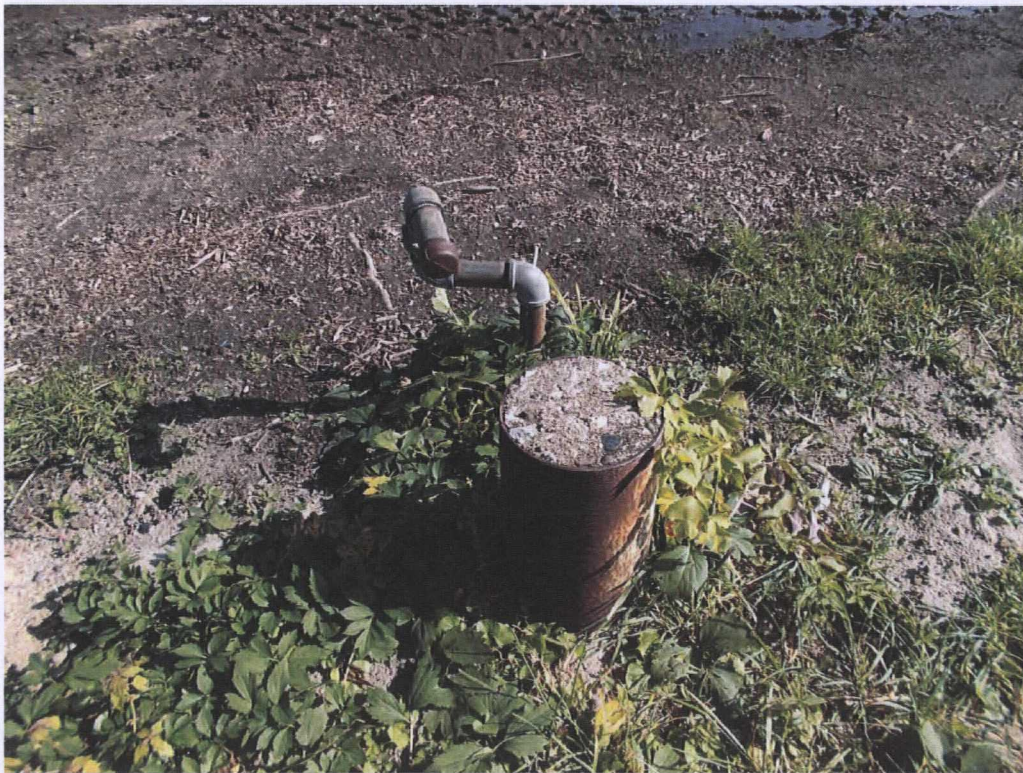
East bollard and suspected abandoned gas main

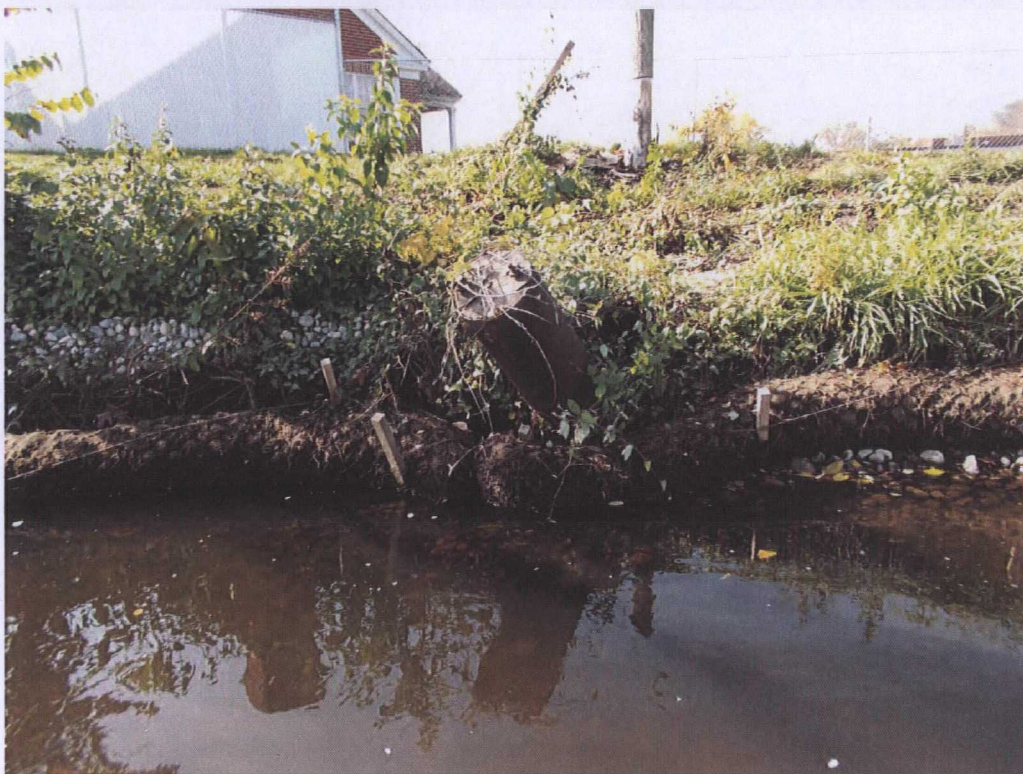
- The west bollard appears to be leaning toward the channel more than it was prior to sediment removal, however, the structure appears to be abandoned and likely can be left in place.

View of west bollard leaning toward channel area

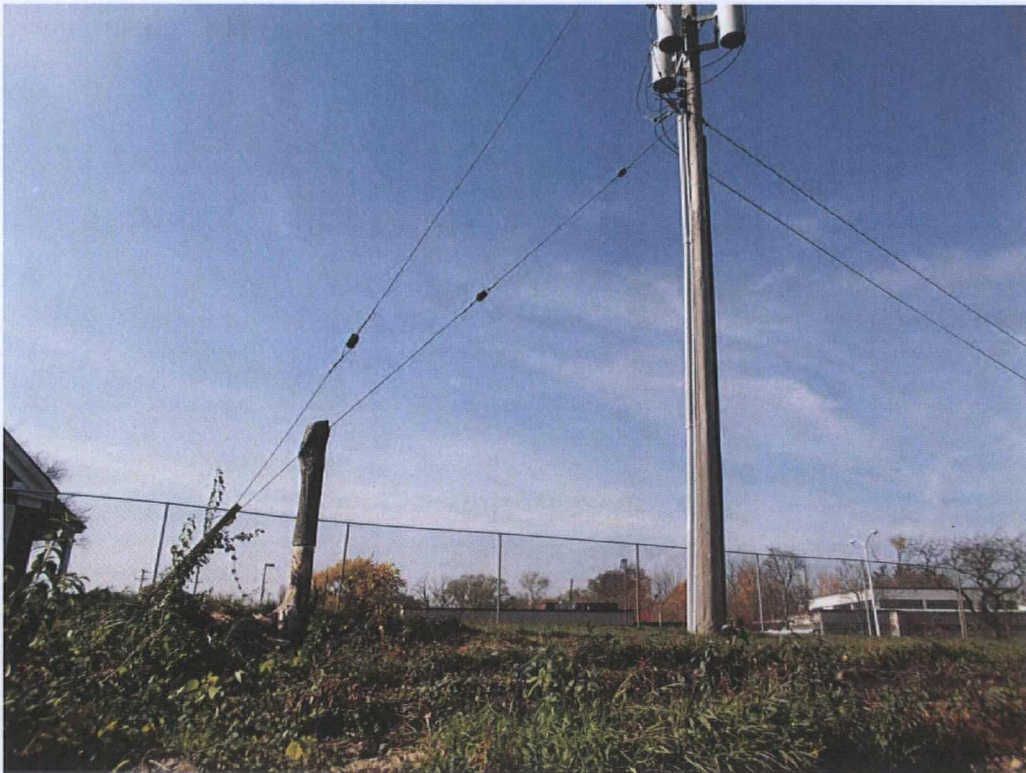
- The structure does not appear to have been impacted during sediment removal.

View of pole and guy from the channel area

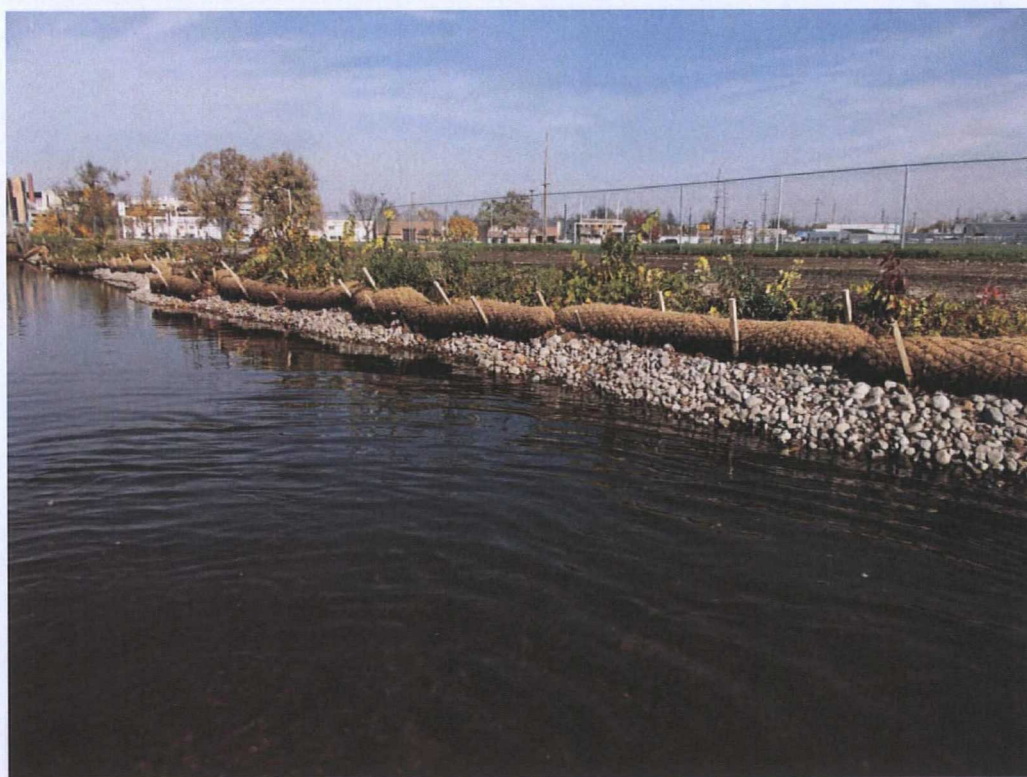
- The structure was removed in conjunction with sediment removal operations.

Bank restoration in the area of the previous structure

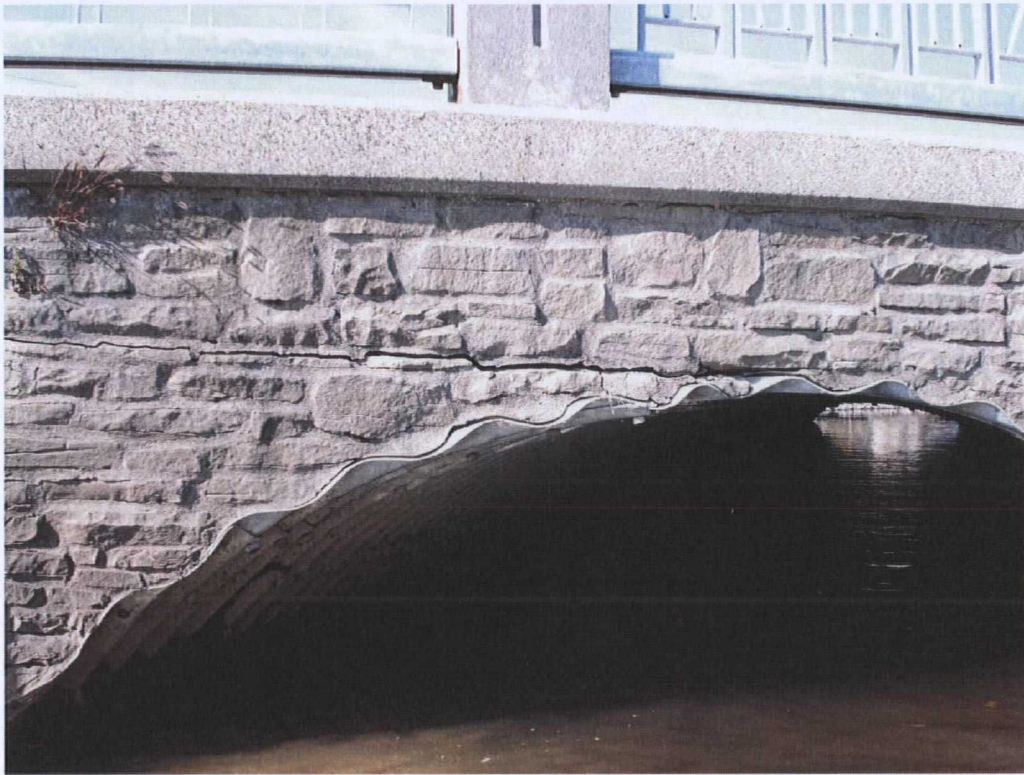
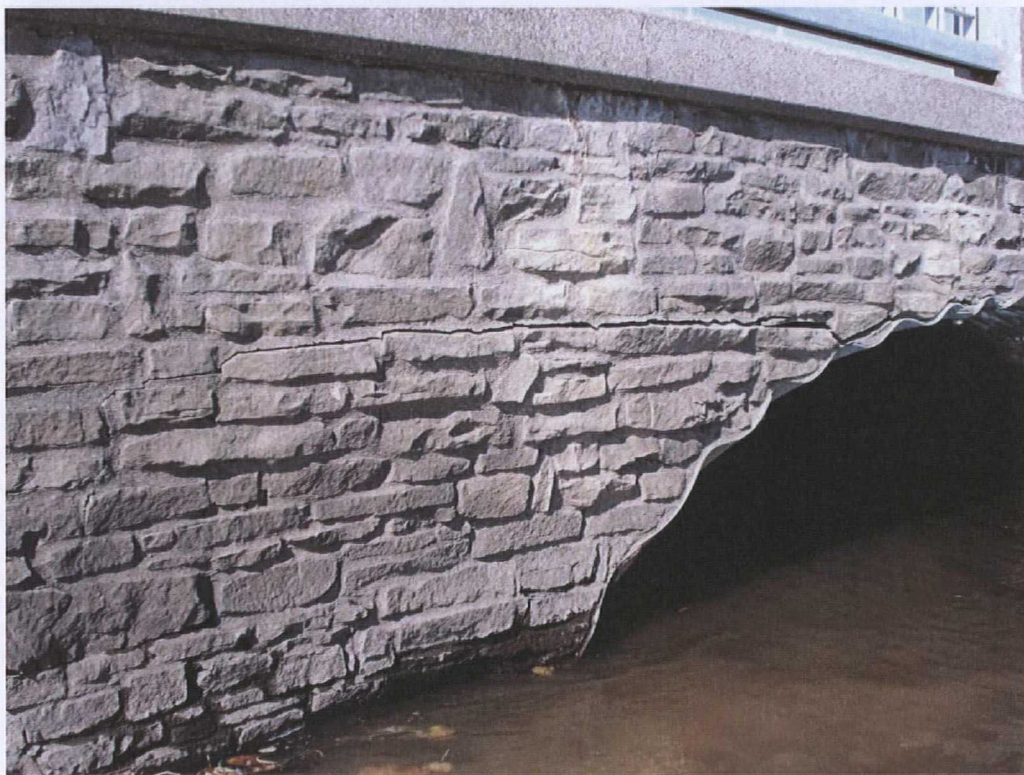
- Cracking in the headwalls appears to be unchanged.
- Cracked sidewalk in the southeast and southwest appears to be marked for replacement, as well as a curb cut in the northeast.
- Restoration is required in the southeast, southwest and northeast quadrants.
- The structure itself does not appear to have been impacted during sediment removal.

Headwall cracking appears unchanged

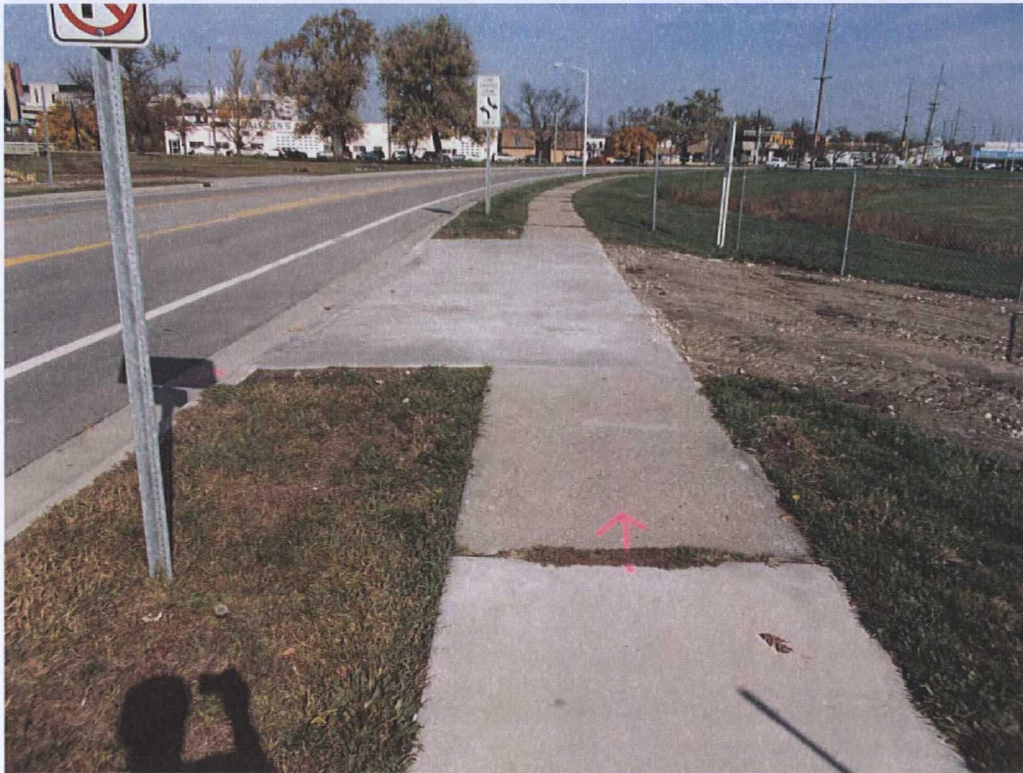
Curb and sidewalk replacement in the southeast quadrant

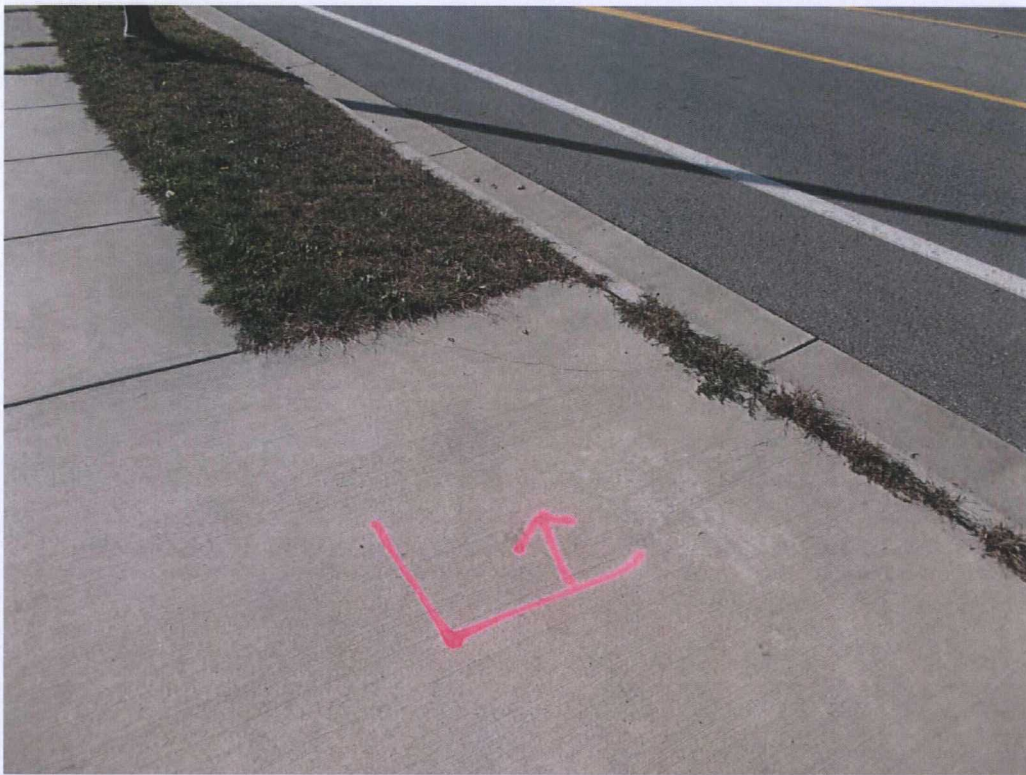
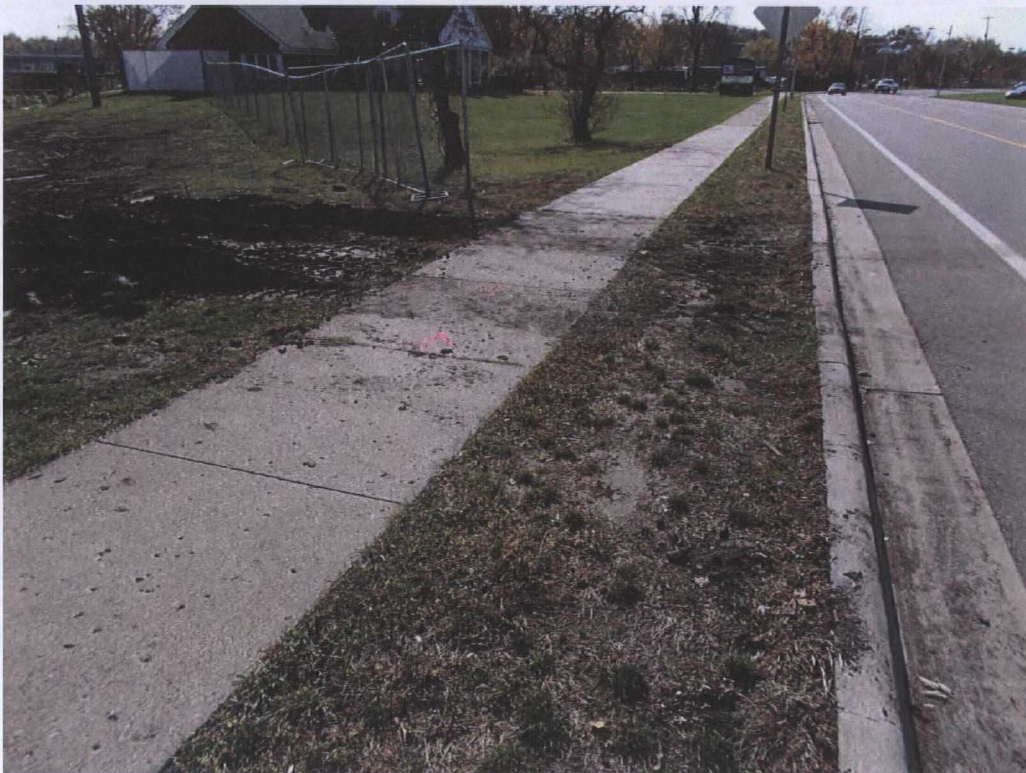
Cracked sidewalk marked for replacement in the southwest quadrant

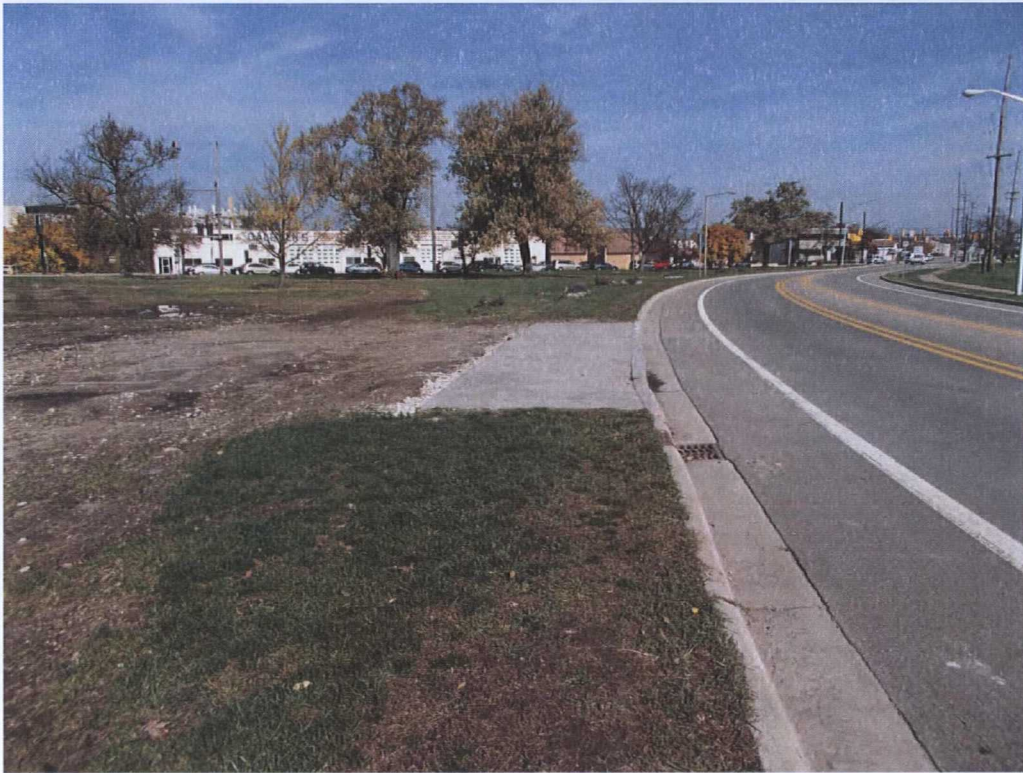
Curb replacement in the northeast quadrant

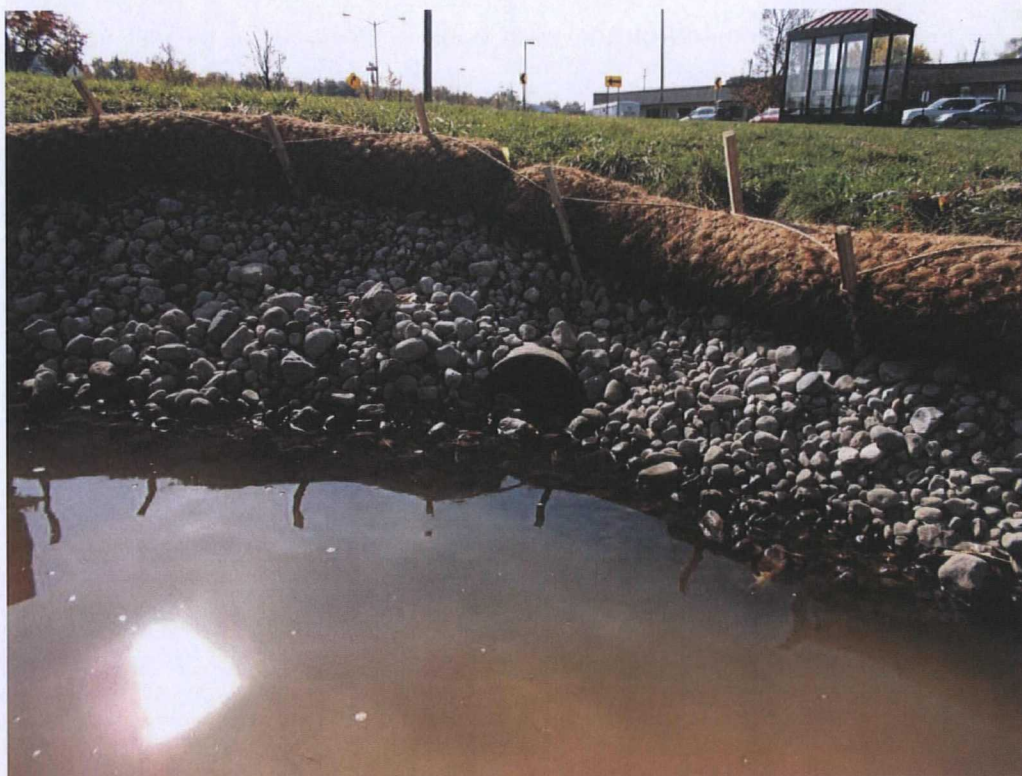
- Failed end sections have been removed. The remaining outlet does not appear to have been impacted during sediment removal.

View of structure from the channel

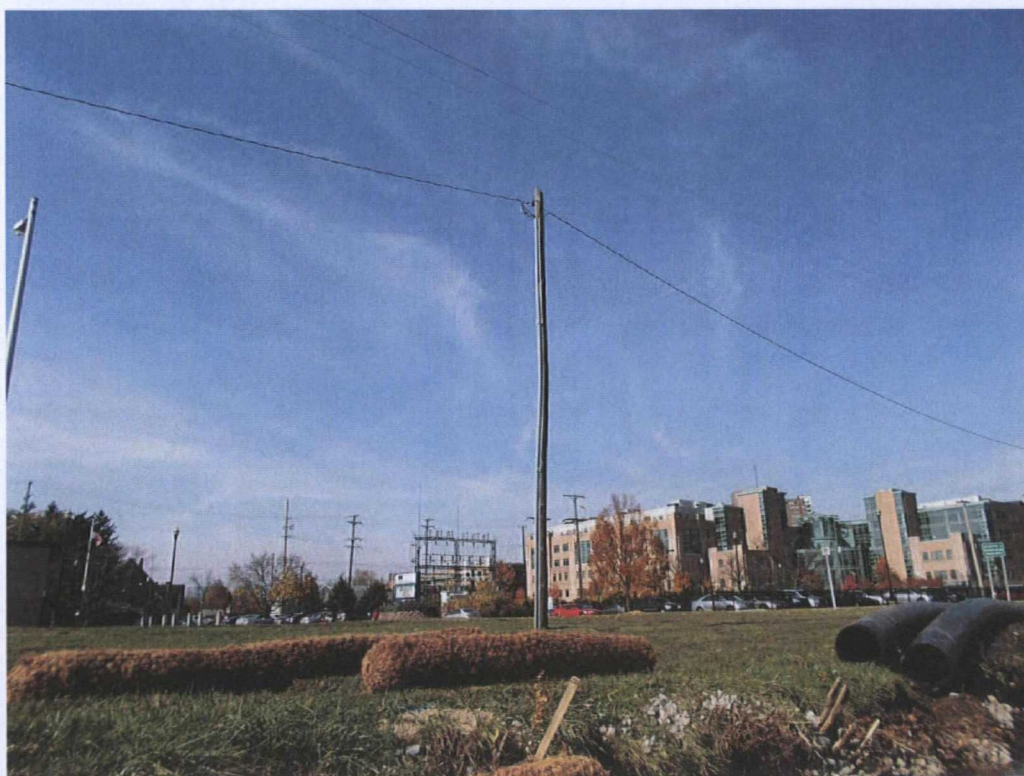
- The structure does not appear to have been impacted during sediment removal.

View of pole from channel

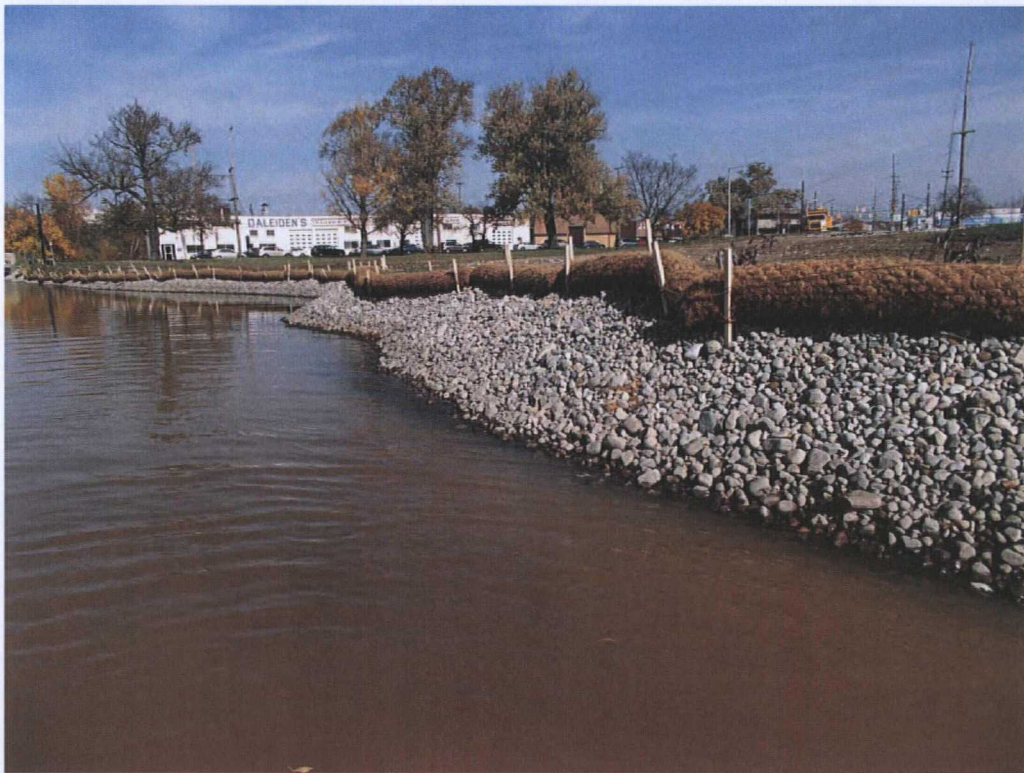
- The structure appears to have been removed during sediment removal. It could not be located during the evaluation. It should be confirmed that the outlet was abandoned.

Bank restoration in the area of the structure

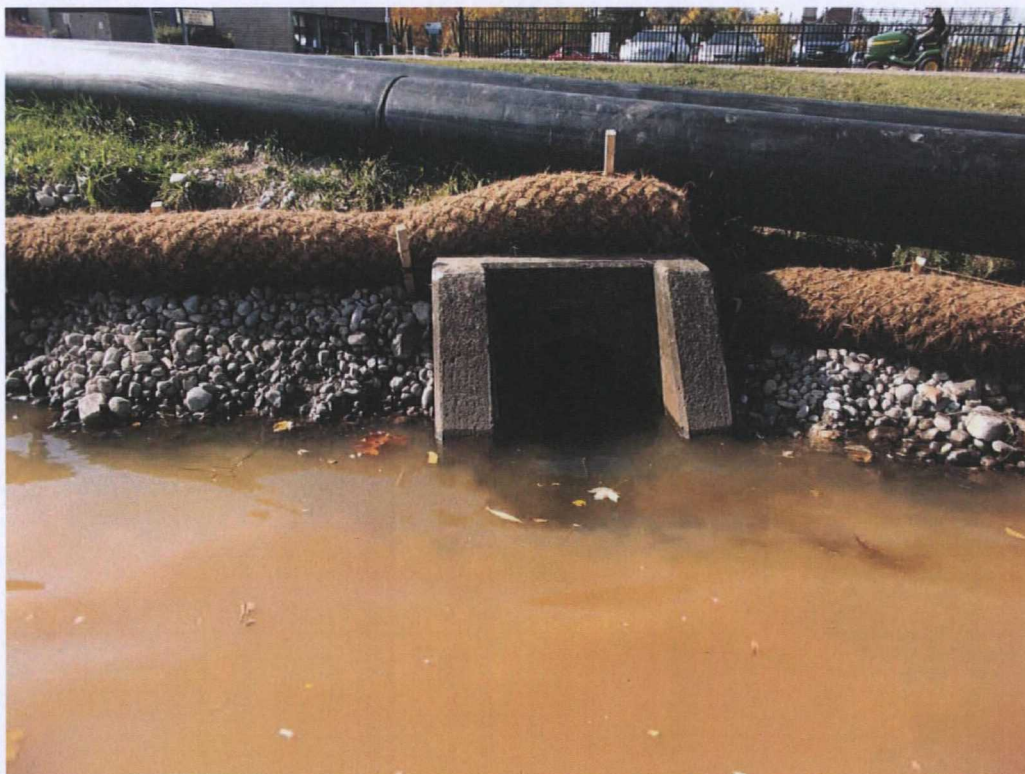
- The structure does not appear to have been impacted during sediment removal.

View of structure from the channel

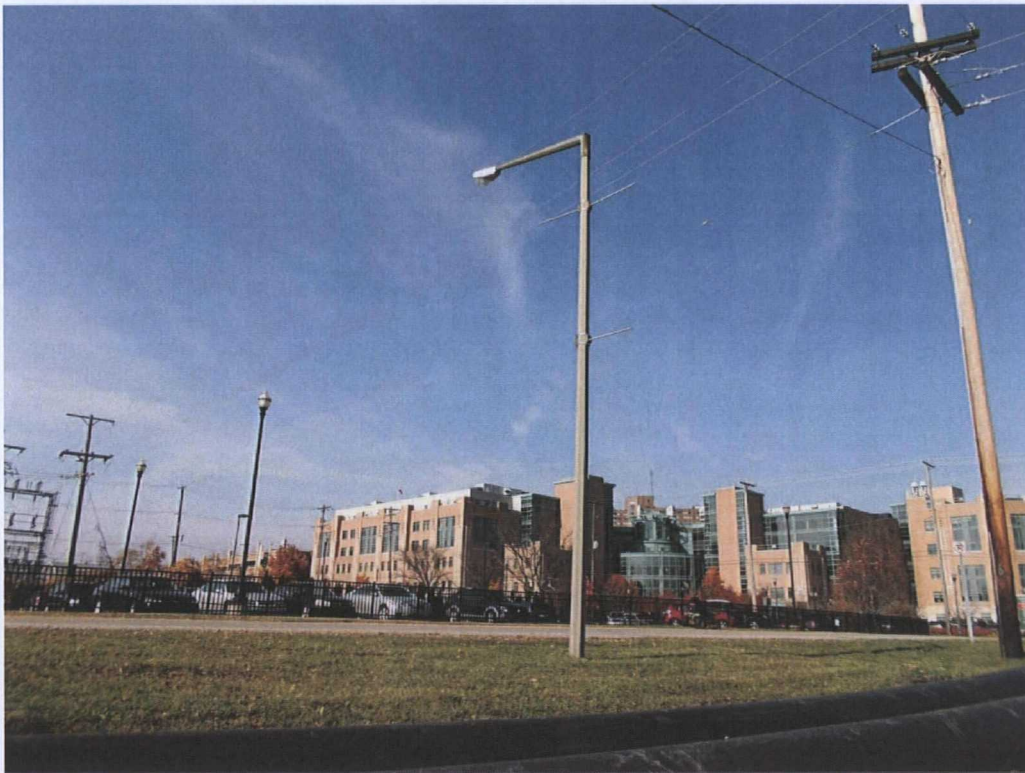
- The structure does not appear to have been impacted during sediment removal.

View of the pole from the channel

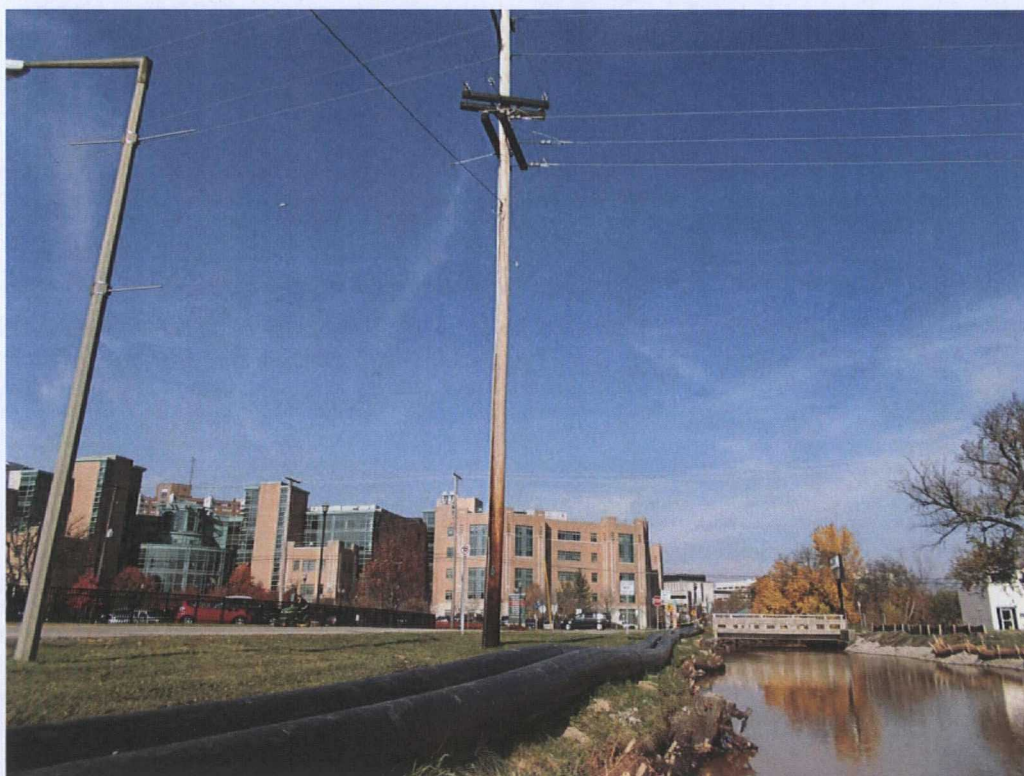
- The structure does not appear to have been impacted during sediment removal.

View of the pole and guy from the channel

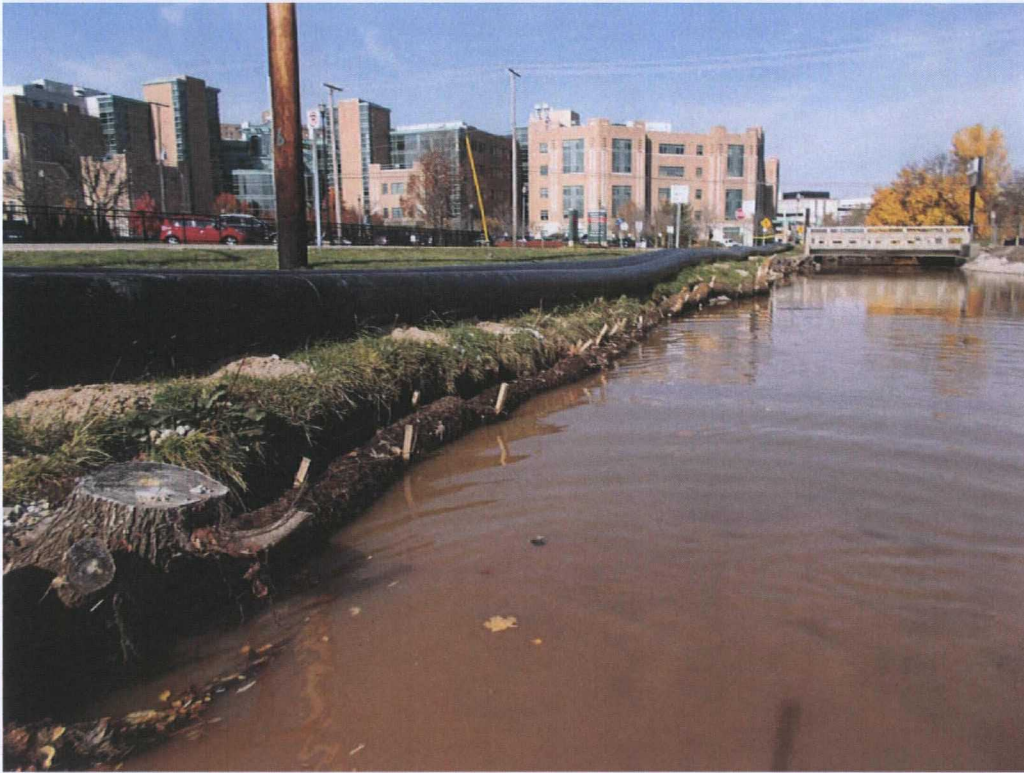
- The structure was removed in conjunction with sediment removal operations.

Bank restoration in the previous area of the structure

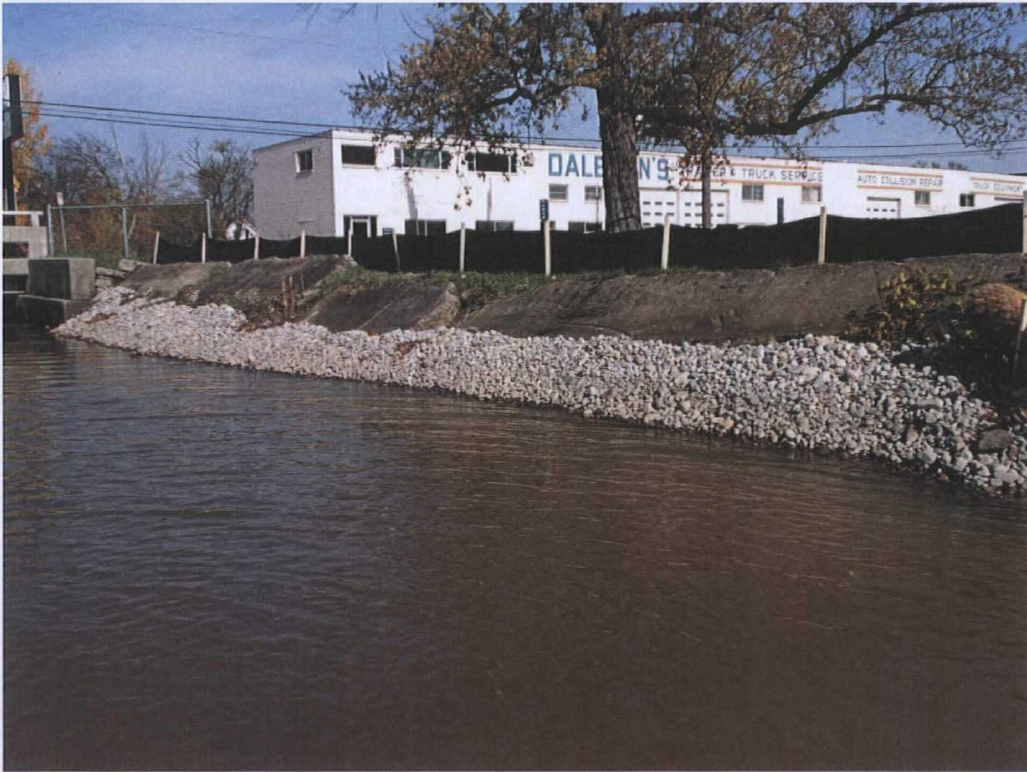
- The structure does not appear to have been impacted during sediment removal.
- The bank has been restored around the structure.

View of the structure from the channel

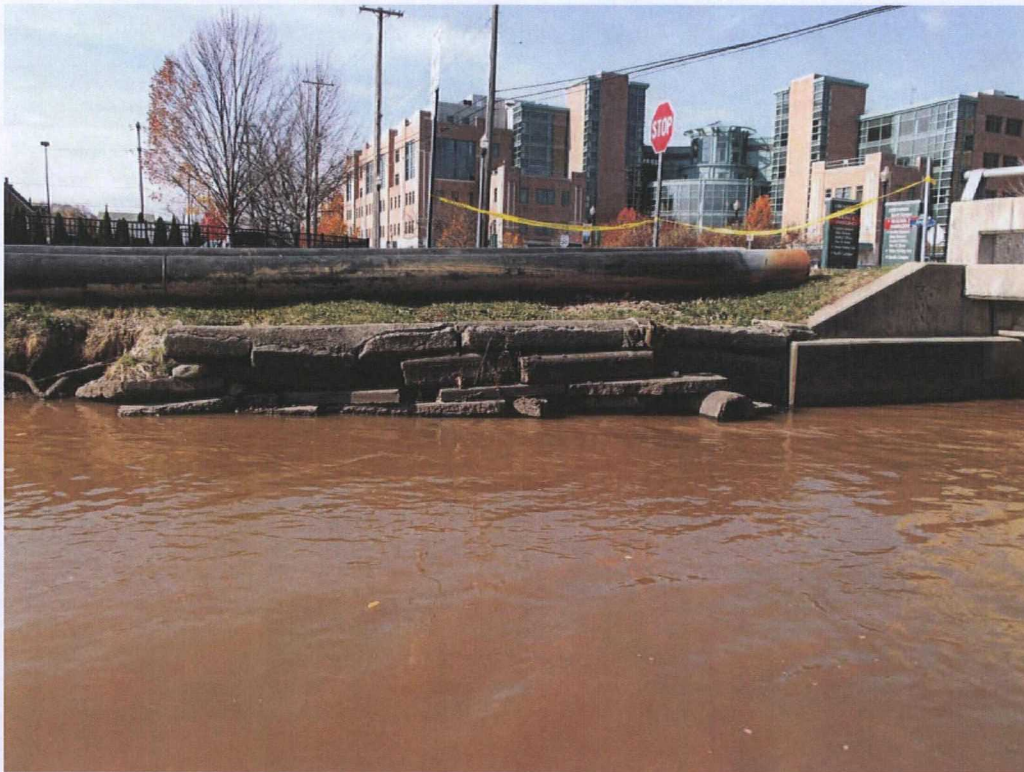
- The structure does not appear to have been impacted during sediment removal.

View of the structure from the channel

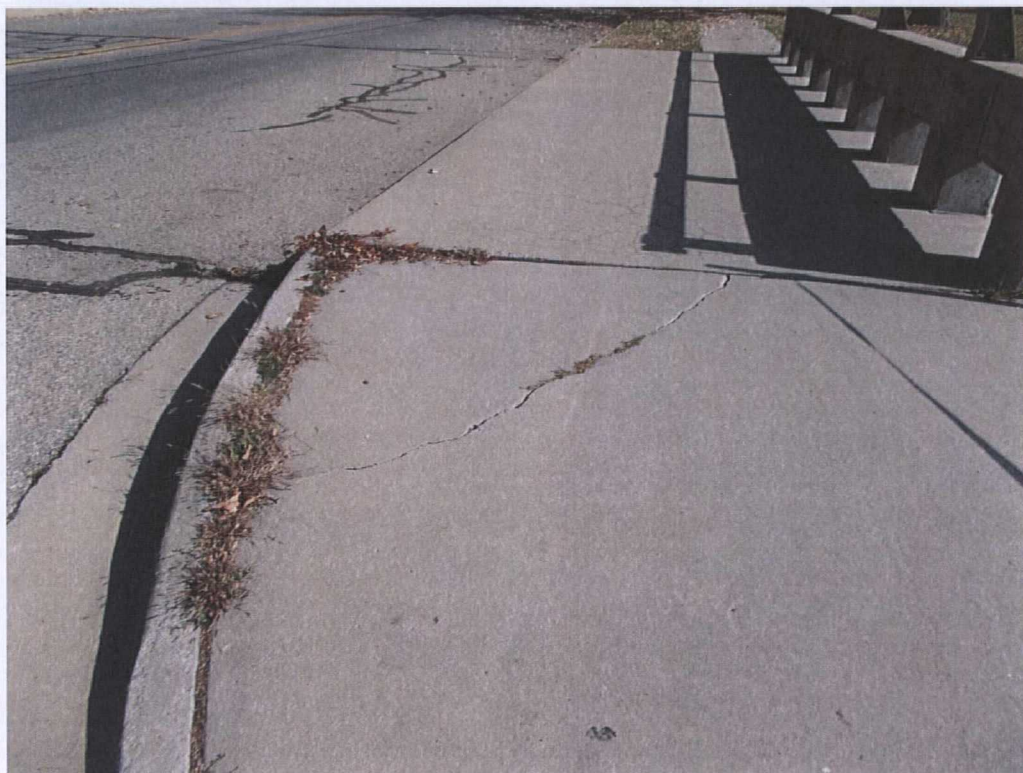
Previous cracking in southwest sidewalk
